# Jarðhýsi á Eiríksstöðum

2023 Hugmyndavinna

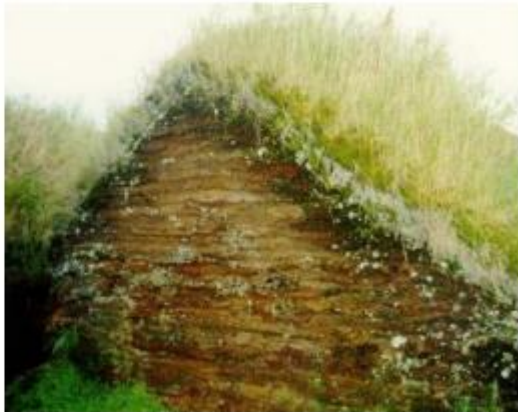
Norðurgafli baðstofunnar í Glaumbæ er hlaðinn úr strengjum sem ristir eru úr mýrinni með torfljá í þunnum lögum. Þök voru tyrfð með torfum eða grundartorfi.
